Avolites LTD Engineering Change Notice

ECN title	Sapphire motor fader belt repair

ECN Number	ECN-0211		
Related Product(s)	All Sapphire Touch console up to ST-0274 All Sapphire fader wings up to STFW-020		
Date / Author	09/05/2015	JB Toby	
Reasons for ECN	Weak clamping of the belt allows for the belt to slip and damage to the belt		
Parts required	RTV Silicone Adhesives, see below for specification Small cable tie to apply adhesive		
Tools required	Tools to remove fader PCB.		
Estimated time	15 Minutes per board once removed from the console A whole console takes up to 3 hours excluding curing time. (PCB remove, inspect and modify faders, PCB replace, test console.

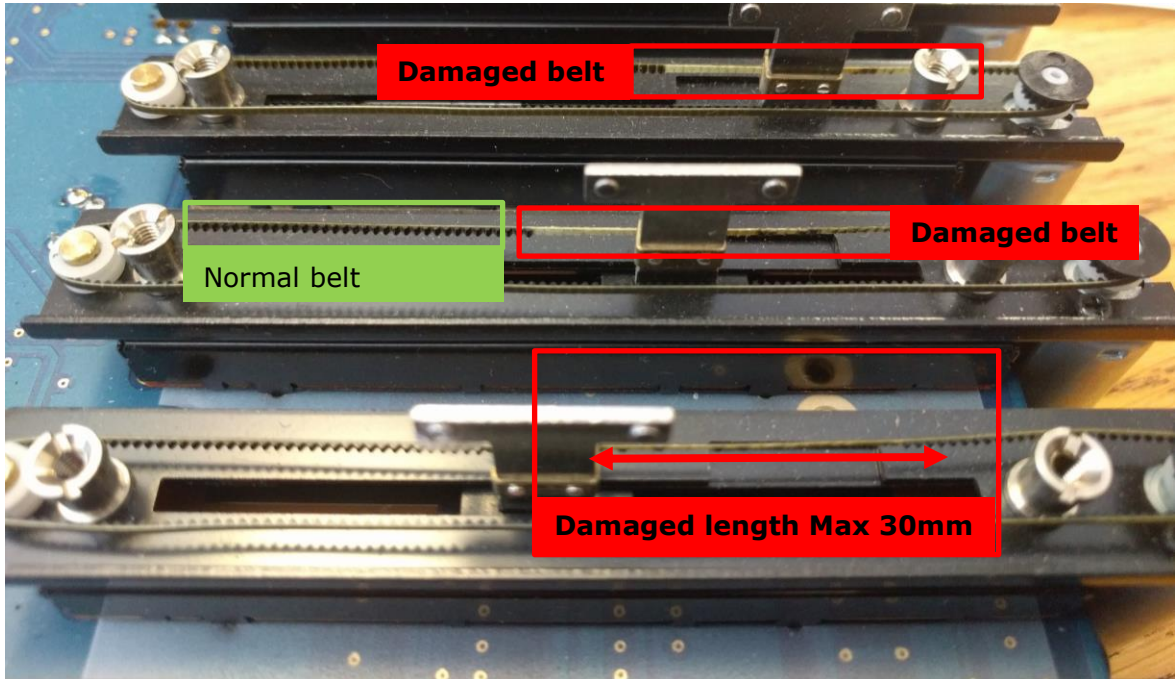
1. Inspect each fader for belt wear (missing tooth).

Check that the belt wear is not too long, the maximum damaged belt length is 30mm

2. If the belt is damaged over a length longer than 30mm replace the fader, (See image above)
3. Check that the motor pulleys is not raised more than 1mm above the, normally the shaft is about 0.5mm under the head of the pulley

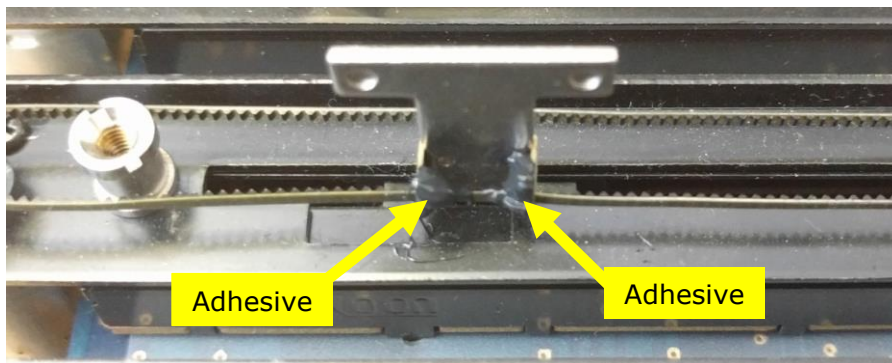
- B. Apply two small dabs (see below for sample size) of adhesive on the **inside** of the fader shaft clamp, make sure to work the adhesive onto the belt as well as the clamp.

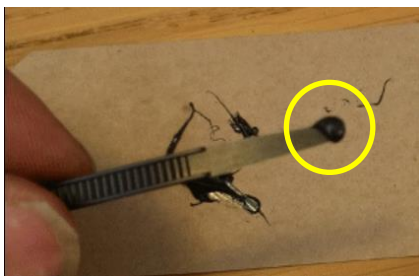
Sample size of amount of adhesive, circa 3mm sphere.
